Sunwise Cooperative: Affordable Solutions to Thermal Discomfort

ABT 212: Path to Zero Net Energy

EXECUTIVE SUMMARY

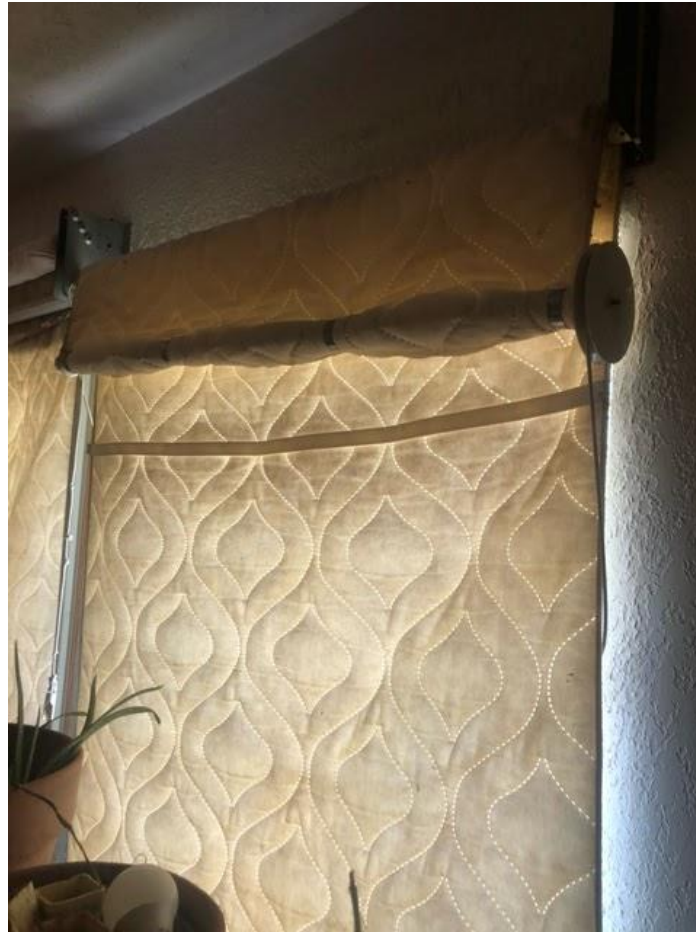
Figure 1. Sunwise Cooperative has several thermal curtains. Some thermal curtains or curtain rods are in need of repair.

As mentioned earlier in this report, the Sunwise Cooperative has thermal curtains in the communal spaces, but some of these curtains are currently inoperable. After one of the site visits, the residents mentioned that the thermal curtains of the lower half of the big south window were taken out sometime; thus it would be recommended to put them back in place so that they can be operated. Additionally, the residents pointed out that the curtain located in the right upper half of the big south window is inoperable

and that it might be broken. After analyzing close-up photos of the curtain rod and videos of the curtain rod, the authors concluded that the curtain rod is only out of place. They anticipate that this will be an easy repair, as it is very likely that the curtain rod just needs to be inserted back into the support's holes.

Repair of the thermal curtain located on the right top half and installation of the one that belongs to the lower half of the big south window are expected to be easy tasks. For both of them, residents can simply place the curtain rods back into the support's holes.

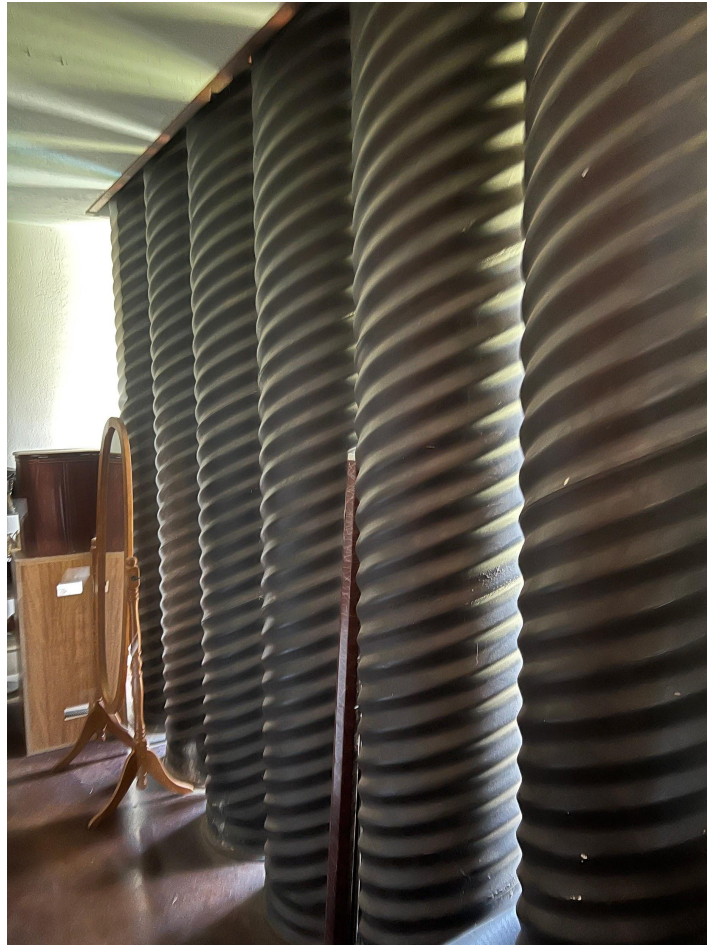
Figure 2. Sunwise Cooperative thermal storage pillars.

The Sunwise Cooperative has thermal storage pillars located immediately adjacent to the windows on the south side of the house. The residents are unsure if the thermal storage pillars work, and they are not sure how to operate them to benefit from passive cooling in the summer and passive heating in the winter. The authors consulted with Hammond + Playle Architects, LLP to identify best practices to optimize the utilization of the thermal storage pillars since this company specializes in passive solar heating and cooling and performs and advises the installation of such thermal storage pillars.

Before these steps in Figure 5 can be taken, there are prerequisite steps which should be taken. Firstly, the thermal storage pillars should be filled with water. The efficacy of thermal storage pillars relies on these pillars being filled with water; since water has a high specific heat capacity, it provides substantial thermal mass to be used for heat storage. The client must determine if the thermal storage pillars are filled with water, and if they are not, then to fill them. Secondly, the windows and thermal curtains adjacent to the thermal storage pillars should be made accessible to the residents. This is discussed further in Section 3.3.1. and Section 3.3.3., respectively.

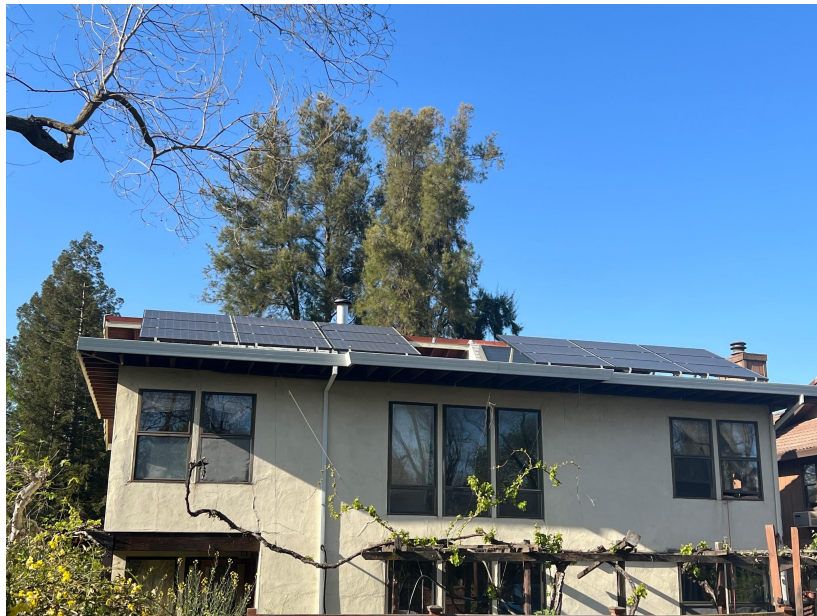
Figure 3. Sunwise Cooperative solar panels.

Cleaning rooftop solar panels is another option. However, one study found that the estimated improvement by cleaning solar panels is approximately 1% [3]. Nevertheless, cleaning solar panels will be an option for reducing energy bills without additional money. It is generally recommended to clean solar panels every 6 months to a year.

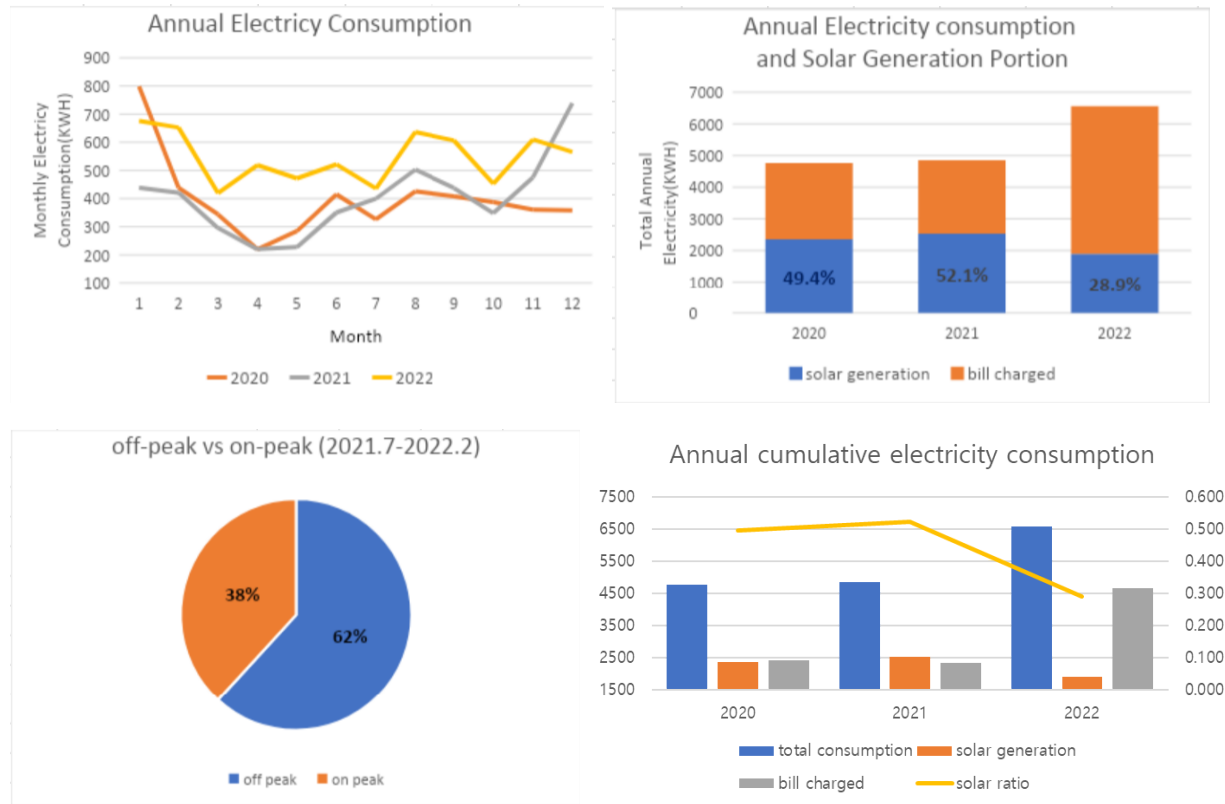
Figure 4a,b,c,d. Electricity bill analysis shows that solar electricity production decreased in 2022. The authors suggest that the residents regularly hose down the solar panels every few months to ensure higher solar electricity production. Otherwise, the Sunwise Cooperative consumes a lot less electricity than an average California 10-occupant residence.

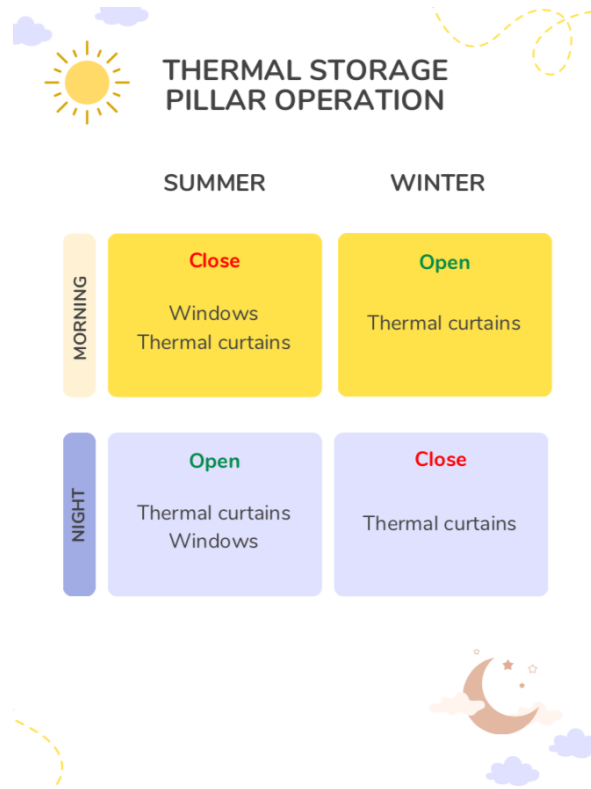
Figure 5. Following consultation with Hammond + Playle Architects, LLP; the authors created the following infographic for the residents to reference for optimal operation of the thermal storage pillars. Intended for print and posting near the thermal pillars.

Findings from this consultation are threefold; the proper operation of the thermal storage pillars require proper utilization of the adjacent windows and their corresponding thermal curtains. These findings are summarized in an infographic (see Figure 5, Appendix C) which was delivered to the client for residents' reference.

As shown in the infographic referenced above, the proper operation of the thermal storage pillars in the summer consists of the following steps:

1. Open thermal curtains and windows at night to benefit from convective cooling of the pillars and of the indoor space. This will cool the pillars overnight.
2. Close the windows and thermal curtains during the day to block out the radiant heat. Then, the thermal storage pillars will cool off the house during the day from the cooling acquired the night before.

Conversely, in the winter, the thermal storage pillars should be utilized with the following steps:

1. Open the thermal curtains during the day to benefit from the radiant heating of the thermal pillars and of the indoor space. This will heat the pillars during the daytime.
2. Close the thermal curtains during the night to help with insulation so as to discourage heat transfer from the house to the outside via the windows. Then, the thermal storage pillars will heat the house during the night from the heating acquired during the day.
